## MAPPING OF FIRE EXTINGUISHER: A CASE STUDY IN ISLAMIC BOARDING SCHOOL GONTOR 2 PONOROGO

<sup>1,2,3</sup>Prodi Keselamatan dan Kesehatan Kerja, Fakultas Ilmu Kesehatan, Universitas Darussalam Gontor

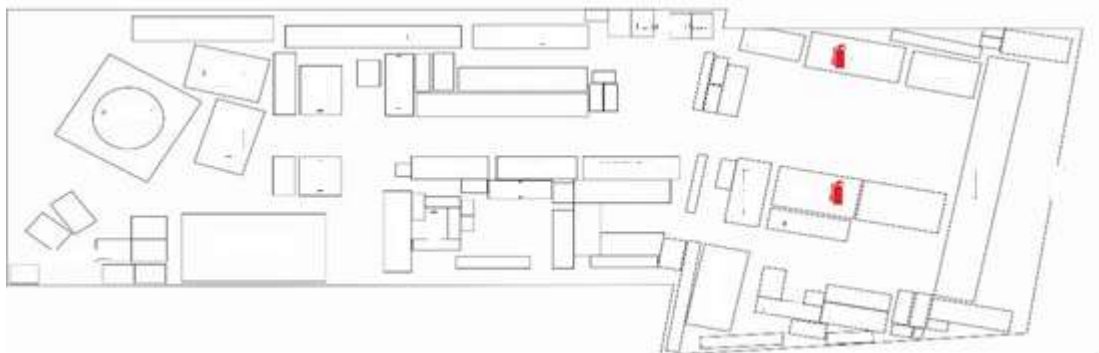
**Figure 4.** Islamic Boarding School Gontor 2 Map Before Analysis was Conducted

The following is a floor plan of the Islamic Boarding School Gontor 2 Ponorogo before the active fire protection mapping analysis was carried out throughout the Gontor 2 Islamic Boarding School area (Fig. 4)

Based on the observation results (Figure 4), there are two fire extinguishers placed in different rooms, at a close distance so that they are collected in one place. So the number of fire extinguishers is still inadequate and their distribution is not yet comprehensive in the Islamic Boarding School area and there are no hydrants. Islamic Boarding School Gontor 2 Ponorogo only has two fire extinguishers installed in the front room of the Islamic Boarding School, so fire extinguishers are collected in one area, while other areas have not installed fire extinguishers. So after carrying out the analysis, it was found that there was a need for 30 units of fire extinguishing equipment for areas that had not been installed. Research conducted by Jevtić states that the most important thing in optimizing an active fire protection function is the correct number and position of installation and in accordance with applicable procedures (24).

In multi-storey buildings such as dormitories and classrooms, there are no portable fire extinguishers, which based on the mapping results should be 30 units. Safety signs such as Evacuation Routes which based on the mapping results should be 22 units and Assembly Points which based on the mapping results should be 2 units, so that guests from outside the Islamic Boarding School who come do not know where the evacuation route is in the event of a fire or emergency. And there is no Assembly Point to accommodate people who gather when a fire or emergency occurs.

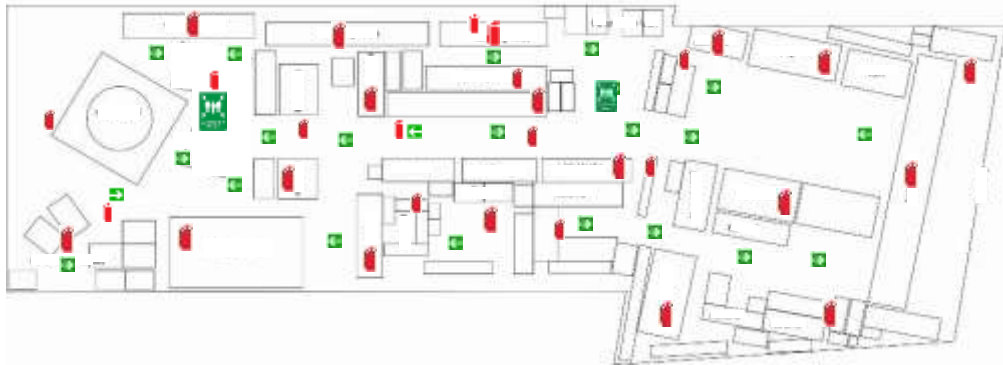
**Figure 5.** Mapping Recommendation for Islamic Boarding School Gontor 2 Ponorogo After Analysis was Conducted

The placement of fire extinguishers is regulated in government regulations (25) namely: a) each one or group of fire extinguishers must be placed in a position that is easy to see clearly, easy to reach and take and equipped with installation markings, b) the height of the installation markings is 125 cm from the bottom of the floor directly above one or a group of fire extinguishers are concerned, c) the installation and placement of fire extinguishers must be in accordance with the type and classification of fire, d) the placement of one fire extinguisher with another or one group with another must not exceed 15 meters, unless otherwise determined by a supervisory employee or work safety expert, e) all fire extinguisher cylinders should be red. Thus, researchers provide recommendations for installing fire extinguishers, installing safety signs, assembly points and evacuation routes as follows (Fig. 5):

Based on observations, the multi-storey building and rooms at the Islamic Boarding School Gontor 2 Ponorogo have 2 fire extinguishers placed in the front room at a distance of about 30 meters, but do not have and have not yet installed safety signs and assembly points. This is not based on the Regulation of the Minister of Manpower and Transmigration of the Republic of Indonesia Number 4 of 1980 concerning Installation and Maintenance Requirements for Fire Extinguishers which states that the standard distance for fire extinguishers is 15 m.

If calculated correctly on a building size of 75 x 30 meters with an area of approximately 10 ha but minus the futsal field and area, then 30 units of fire extinguishers are needed on each floor and in each room. This is also supported by the results of Lufyana's research in industry which states that workers have difficulty putting out fires if the fire is more than 15 meters away (26).
